# 2012 SOUTH RIVER FISH COMMUNITIES AND PHYSICAL HABITAT ASSESSMENT, FRANKLIN COUNTY, MASSACHUSETTS

DRAFT REPORT

## EXECUTIVE SUMMARY

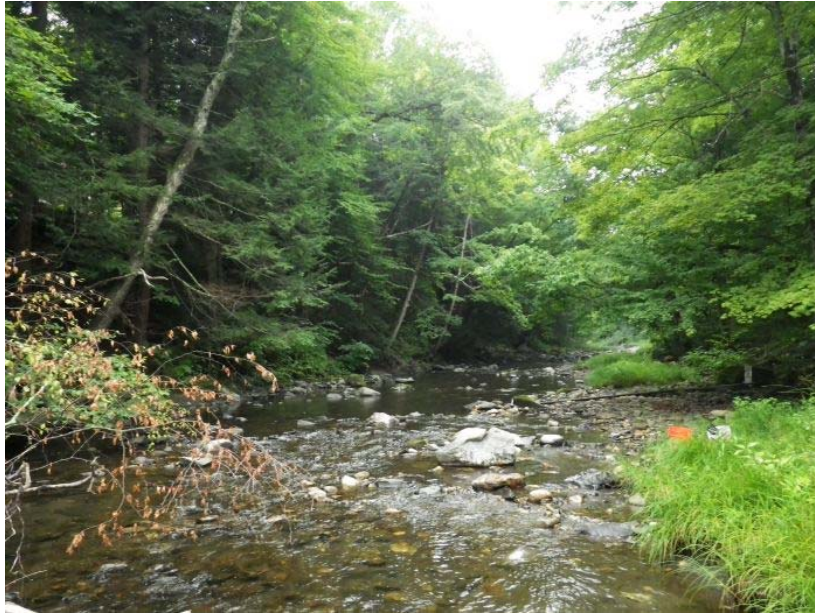
### REACH F1 (RIVER MILE 2.6) - IMPACTED

Reach F1 occurred immediately upriver of the Reeds Bridge Road bridge at river mile 2.6. This study reach occurred within the Geomorphic Assessment Reach 7A, one of the most impaired segments in the watershed (Field 2013). This reach occurs in a section of river transitioning from a wide to narrow floodplain immediately before entering the steep V-shaped valley through which the river flows for the last two miles before entering the Deerfield River. As such, the channel gradient and confinement have both increased relative to the upriver sections flowing through the Conway agricultural zone, providing less opportunity for lateral channel movement. A very narrow floodplain occurs on river left through this reach.

This reach is wide and shallow, supporting low habitat complexity or instream cover. Wetted thalweg depth averaged only 0.1 m, despite an average wetted width of 11.8 m. Pool habitat is scarce (4% of reach habitat), and that available is shallow and filling with sediment. Despite a large mean substrate particle size of 319 mm, substrate embeddedness by fines and sand was 48%. Large woody debris was absent from the reach, and fish cover index scores were among the lowest measured across all habitat assessment reaches.

High summer-time water temperatures and poor habitat conditions measured in this reach are exemplary of much of the lower river below Conway. The Geomorphic Assessment completed in conjunction with this habitat study provides significant detail and insight into the processes that have produced these degraded conditions in the lower river and offers solutions that would benefit river habitat.

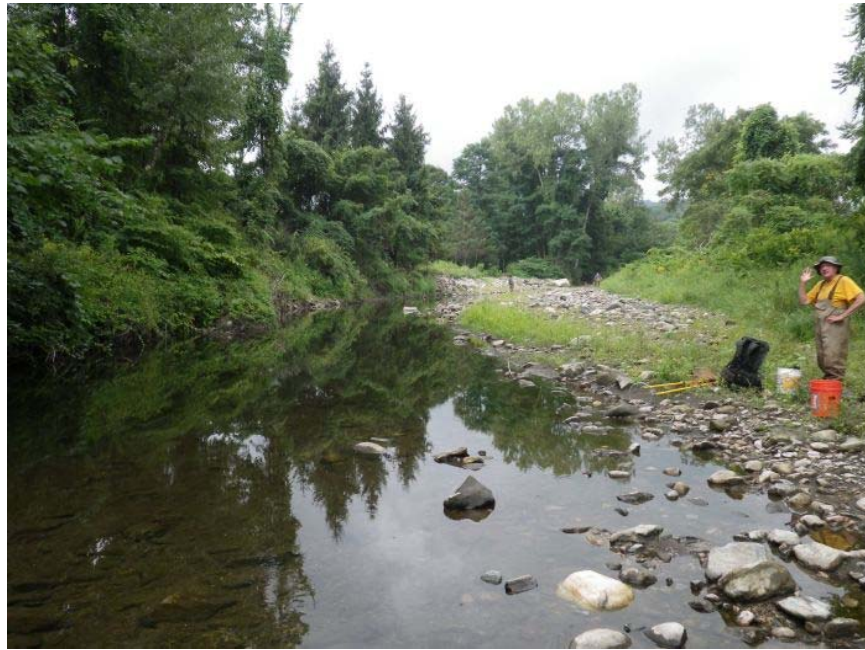
## REACH F2 (RIVER MILE 5.4) - IMPACTED

Reach F2 occurred at the lower end of a section of river approximately 300 m below the Main Street bridge in Conway Center. This reach was selected to exemplify the unsuitable habitat conditions prevalent in the lower river as a result of historic straightening of river segments. This study reach occurred within the Geomorphic Assessment Reach 10E (Field 2013), a section of river that is characterized as low-gradient (0.73%; Field 2013) and unconfined, which will produce in a meandering channel planform. In its current straightened condition, the river is attempting create meanders via bar development and lateral erosion. This section of river has been identified as a priority restoration location with a total needs score of 31 (Field 2013).

The study reach occurring in this straightened section of river was dominated by shallow pool and glide habitats. In-stream habitat complexity was low, and channel widening due to lateral bank scour resulted in the highest bankfull width-to-depth ration measured among all habitat assessment reaches. Large woody debris was absent from the reach. Bank erosion was rated as moderate, but the true extent and capacity for lateral erosion was likely concealed by late-summer overhanging vegetation. Substrate embeddedness (70.2%) was the highest measured among all reaches, partially influenced by the low gradient and lower-velocity habitats

which allow, but also a consequence of elevated erosion rates in this reach as a result of the channel being maintained in an unstable condition (as described in Field 2013).

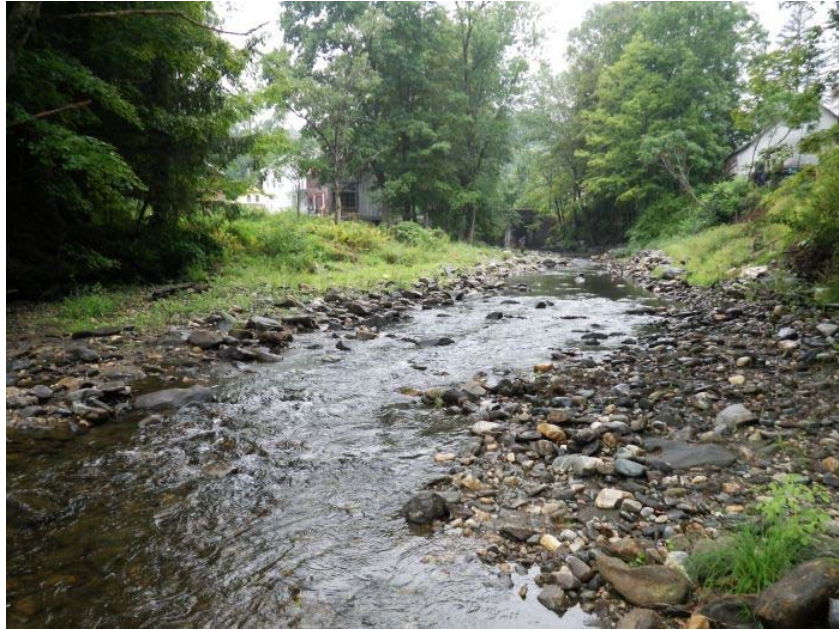
### **REACH F3 (RIVER MILE 5.6) - IMPACTED**

Reach F3 extended from immediately below the confluence with Pumpkin Hollow Brook downriver to approximately 100 m below the Main Street bridge. This habitat assessment reach occurs at the upper end of the Geomorphic Assessment Reach 10. Field (2013) describes this short section of river immediately below the confluence of Pumpkin Hollow Brook as confined by glacial deposits and channel incision. This reach was included in the fish and habitat survey because the upper end of this reach immediately below Pumpkin Hollow Brook has been identified as a priority restoration area (Field 2013). Conceptual restoration plans include the installation of instream deflectors that will potentially increase habitat complexity in the upper end of the reach.

While only ~100 m upstream of the upper end of habitat assessment reach F2, this reach exhibits different habitat characteristics, including larger channel substrate and a more discrete riffle-pool morphology. Habitat was more heterogeneous than immediately downriver, consisting of relatively equal proportions of riffle, pool, and glide habitats. However, pools were small, shallow, and were dominated by fine sediment. No woody debris occurred within the reach. A general lack of instream cover resulted in the lowest fish cover index score among all reaches sampled.

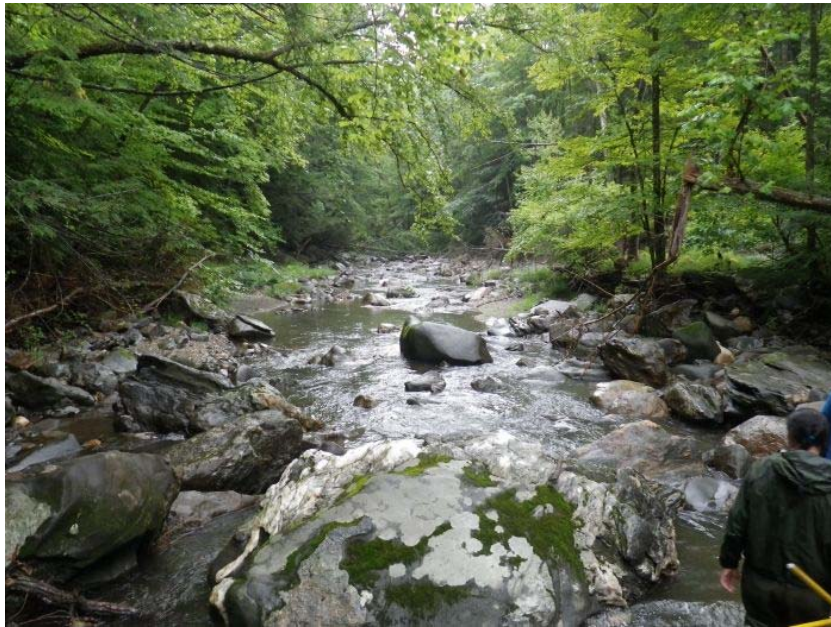
#### **REACH F4 (RIVER MILE 8.3) - REFERENCE**

Reach F4 occurs at river mile 8.3, approximately 300 m downriver of the Route 116 bridge immediately east of Brester Road. This section occurs within Geomorphic Assessment reach 17B, characterized as a steeper, confined channel supporting a step-pool morphology (field 2013). This reach was selected as a reference habitat reach for steeper-gradient sections, as the steep valley walls and mature forested provide a local buffer against any significant channel or riparian alteration. Owing to the higher gradient (1.7%), the increased stream power that occurs in this section effectively transports smaller substrates to downstream reaches, resulting in dominance by cobble and boulder substrates. These large substrates provide complexity in the stream channel necessary to support diverse fish communities; as such, this reach received one of the highest fish cover index scores in the study. Despite a lack of woody debris in the immediate assessment reach, large wood pieces were observed in and spanning over the channel immediately upriver.

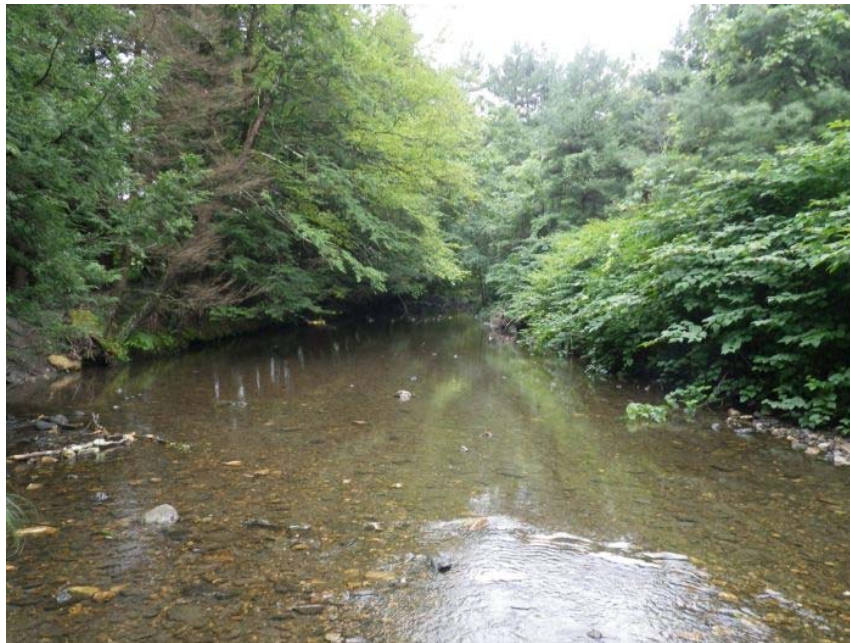
#### **REACH F5 (RIVER MILE 10.0) - IMPACTED**

Fish and habitat assessment reach F5 occurs at river mile 10.0. This section of river occurs upriver of the confluence with Poland Brook, and is characterized as occurring in a wide, lower-gradient valley relative to upriver and downriver sections (Field 2013). This reach occurs within Geomorphic Assessment reach 18G, much of which has historically been straightened and channelized (Field 2013). Habitat assessment reach F5 was established to characterize habitat and fish community attributes under these modified conditions.

Among reaches in the upper portions of the South River, F5 had the highest proportion of glide habitat and the lowest fish cover index score. The reach was dominated by gravel and cobble substrate which was heavily embedded with sediment (60% reach-wide embeddedness), resulting in unfavorable conditions for trout spawning. Water depths were uniformly shallow

The geomorphic assessment identified this section of river as a strong candidate for opportunities for land conversation and restoration projects (Field 2013). Because water temperatures in this reach are likely suitable for supporting wild trout populations and habitat appears to be the primary limiting factor, such projects focused on restoring natural channel processes should restore habitat conditions more suitable for wild trout.

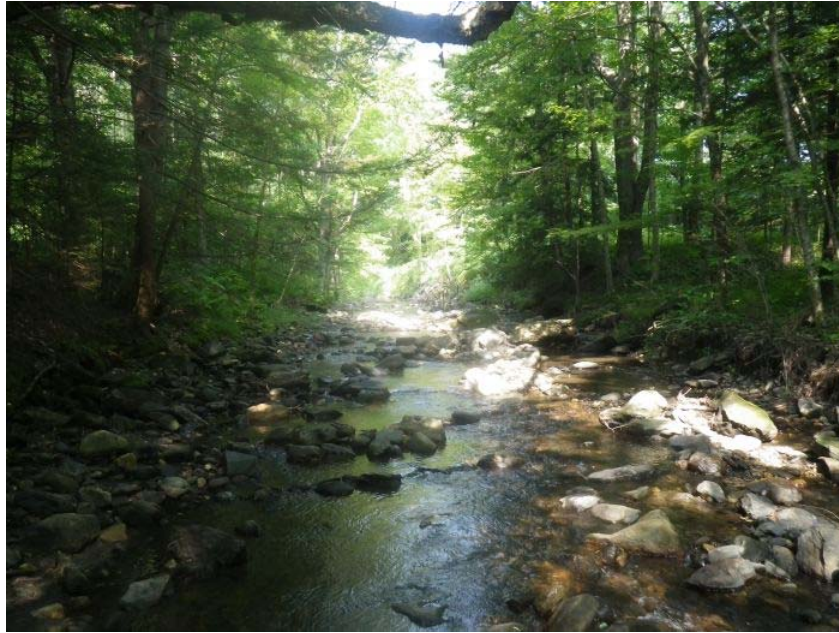
## REACH F6 (RIVER MILE 10.4) – REFERENCE

Reach F6 occurs downriver of the Creamery Brook confluence in a section of the South River that is constrained by a narrow valley. This section of the river exhibits a steep riffle-pool morphology occurring on a 1.9% channel gradient (Field 2013). An intact riparian zone provides ample stream shading and some bank erosion protection from increased sediment loads being delivered from Creamery Brook. Canopy cover was measured as 91%, the highest among all reaches included in the study. Instream habitat is dominated by a relatively even apportioning of riffle and pool habitat, although pool depths were generally shallow as a result of heavy silt and sand deposits.

Substrate consisted of a heterogeneous mixture of grain sizes, dominated by cobble and small boulder. Reach-wide embeddedness was generally low (28%), primarily as a result of the higher stream power's capacity to move sediments through this reach. Despite an absence of instream large woody debris, the instream fish cover index was among the highest in the study as a result of the heterogeneous substrate composition and high frequency of pools.

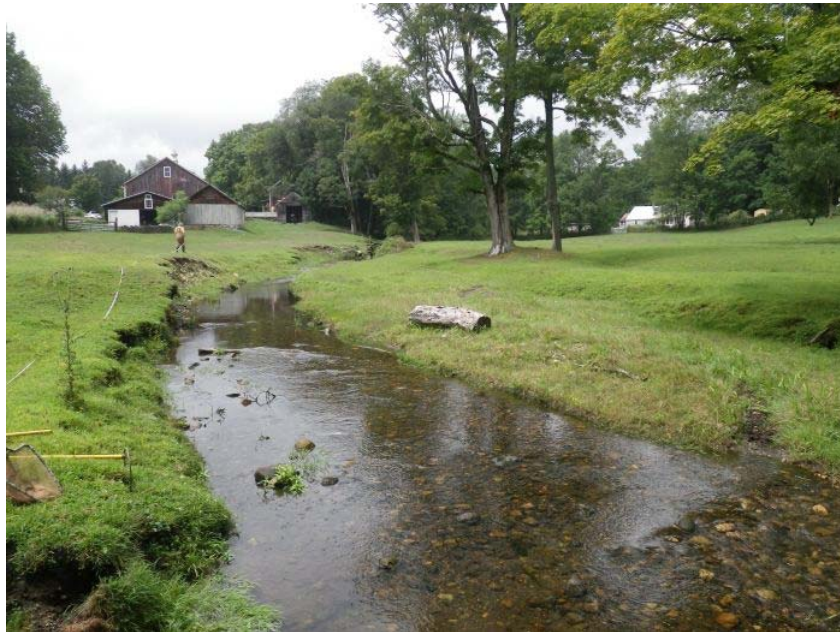
#### **REACH F7 (RIVER MILE 11.3) – IMPACTED**

Reach F7 occurs at river mile 11.3 in an active pasture on the downriver side of Burton Hill Road in Ashfield. This reach occurs within Geomorphic Assessment reach 20A, identified as having severely destabilized banks as a result of active grazing pressure and a lack of riparian vegetation (Field 2013). This reach was selected to represent heavily degraded habitat conditions in this section of the upper river, where agriculture firsts begins to significantly

impact the river along its course to the Deerfield River. This reach is paired with reach F9, occurring another 0.6 miles upriver, and as described later.

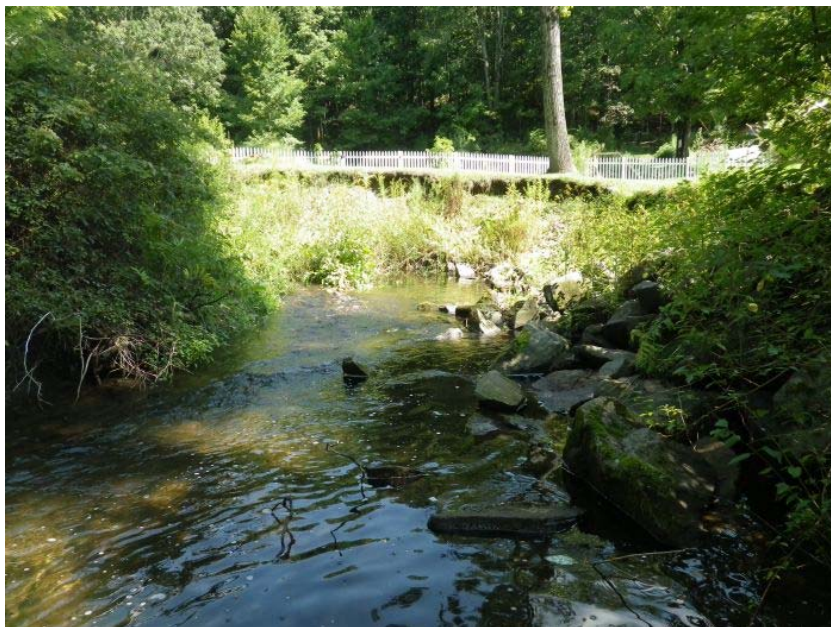
## REACH F8 (RIVER MILE 11.4) – REFERENCE

Reach F8 occurs on the upstream side of Burton Hill Road at river mile 11.4. This reach occurs within the Geomorphic Assessment reach 20B. Although significant bank erosion occurs in this reach, it was assigned to the reference reach class because a sinuous planform and riffle-pool morphology has been maintained through this reach. However, for purposes of assessing the potential condition of reach F7 relative to its current degraded state, it was decided to choose another reference reach further upriver to represent a more stable channel condition with more favorable habitat conditions for wild trout (reach F9).

Significant bank erosion is occurring at the lower end of the reach, in particular, where an absence of riparian vegetation along an outside bend is resulting in property loss. This reach received the third lowest bank stability index rating (8 of 20, marginal). Shallow riffle habitat dominated the reach, interceded by shallow pools and glides. Substrate was dominated by gravel and cobble, with embeddedness averaging 57.2% through the reach. Canopy cover was high through most of the reach (excepting the lawn on river left at the lower end), but the bank protective vegetation index was marginal. This was the first reach within which large woody debris accumulation in the channel was measured; LWD frequency averaged 5.3 pieces/100 m.

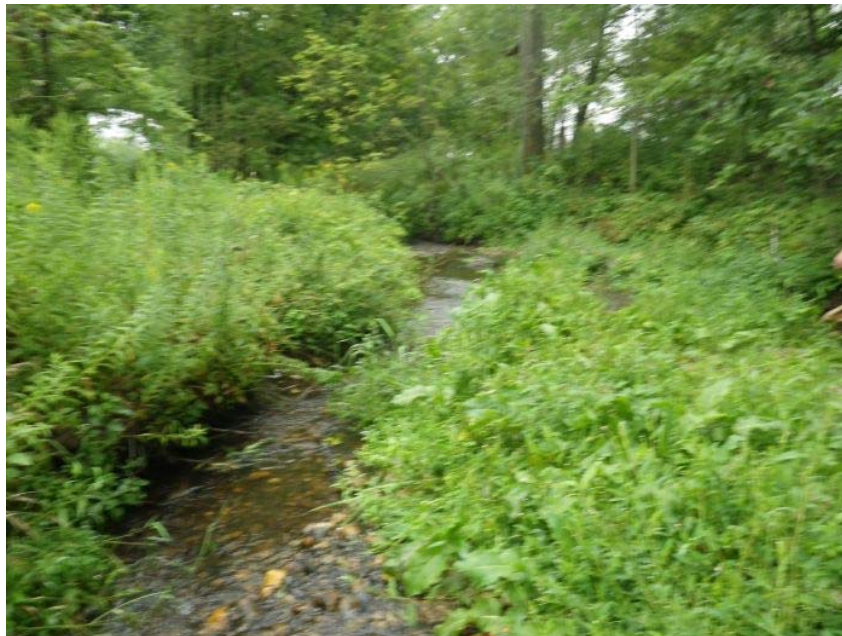
#### **REACH F9 (RIVER MILE 11.9) – REFERENCE**

Reach F9 occurs at river mile 11.9 immediately downriver of the Double Edge Theatre in Ashfield. This reach occurs within the Geomorphic Assessment reach 20D, characterized as having a well-developed floodplain, lower gradient, and riffle-pool morphology. Reach F9 was selected as a reference to represent potentially attainable conditions in reach F7. Reach F9 supported an even mix of riffle and pool habitats, including several pools that were deep and provided cover in the form of root wads and/or undercut banks. Substrate was dominated by

gravels and cobble, and while reach-wide embeddedness was moderately high at 45%, gravel substrates observed at pool tail outs appeared sufficiently clean to support trout spawning.

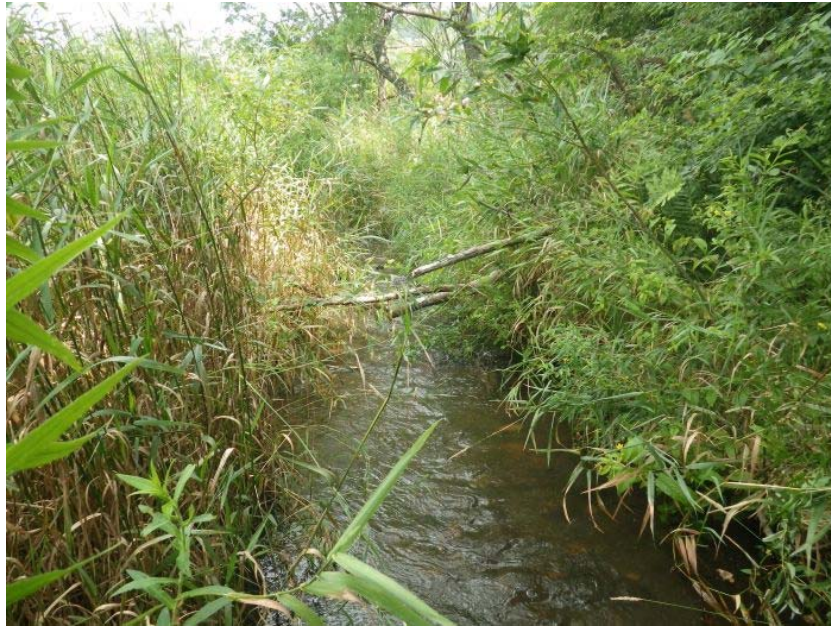
## REACH F10 (RIVER MILE 12.4) – IMPACTED

Reach F10 occurs at river mile 12.4 on the downriver side of Emmett Road in Ashfield. This reach occurs in the Geomorphic Assessment Reach 20F, and was selected to further represent a disturbed channel condition in the upper watershed, impacted by drain tiles, channel straightening, and a lack of a riparian zone on river right (partially missing on river left). Both wetted and bankfull channel dimensions are less than 5 m through this reach, as it appears that some channel incision has occurred through sediments deposited on a wide valley floor.

This reach exhibits a riffle-pool morphology, and while generally shallow, a few deeper pools also occurred within the reach. While trees are absent from the right-bank riparian zone, late summer growth of tall grasses provided ample shading and overhead cover for instream habitat. Consequently, the fish cover index scored in the range of most of the reference sites. Some large woody debris also occurred in the channel. Substrate was dominated by cobble and gravel, and reach-wide embeddedness was moderately high at 43.3%.

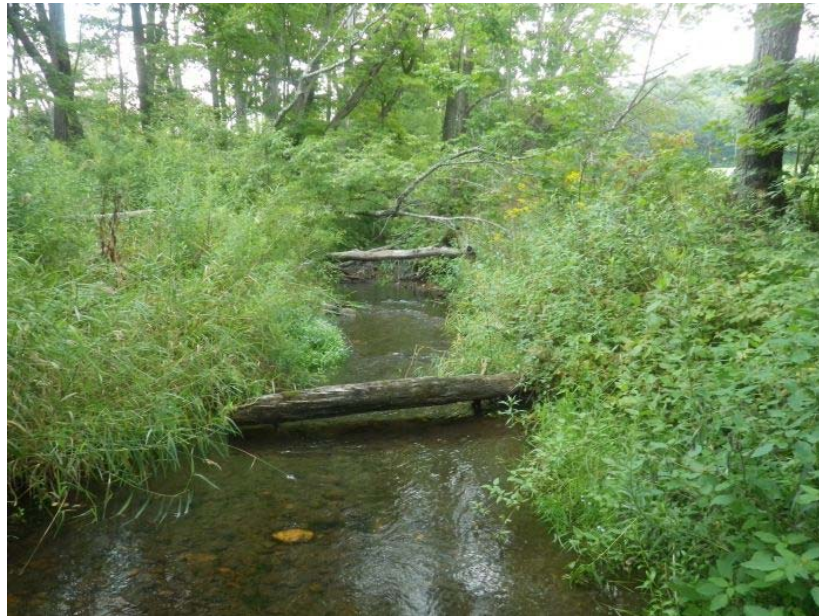
#### **REACH F11 (RIVER MILE 12.5) – REFERENCE**

Reach F11 occurs on the upriver side of Emmett Road at river mile 12.5. This reach was selected to represent reference conditions for reach F10 occurring on the downriver side of the road crossing. In contrast to reach F10, reach F11 is flanked by mature forest (although the buffer width is narrow along a section of the river left bank) and has not been straightened. Despite this more natural planform, frequencies of riffles and pools were similar to those in reach F10, and substrate conditions were slightly less favorable, partially the result of the higher sinuosity in this reach having a higher capacity for sediment storage. Large woody debris loading was the highest measured in the study (17.3 pieces/100 m). Immediately upriver of this reach is a series of beaver dams impounding the South River. These dams appear to impound a significant amount of sediment, and their occasional failures potentially result in periodic influxes of large sediment loads into this reach. An area of mass wasting was also observed at

the upriver end of the reach, which also appears to have recently delivered a large quantity of fine sediment in the reach.

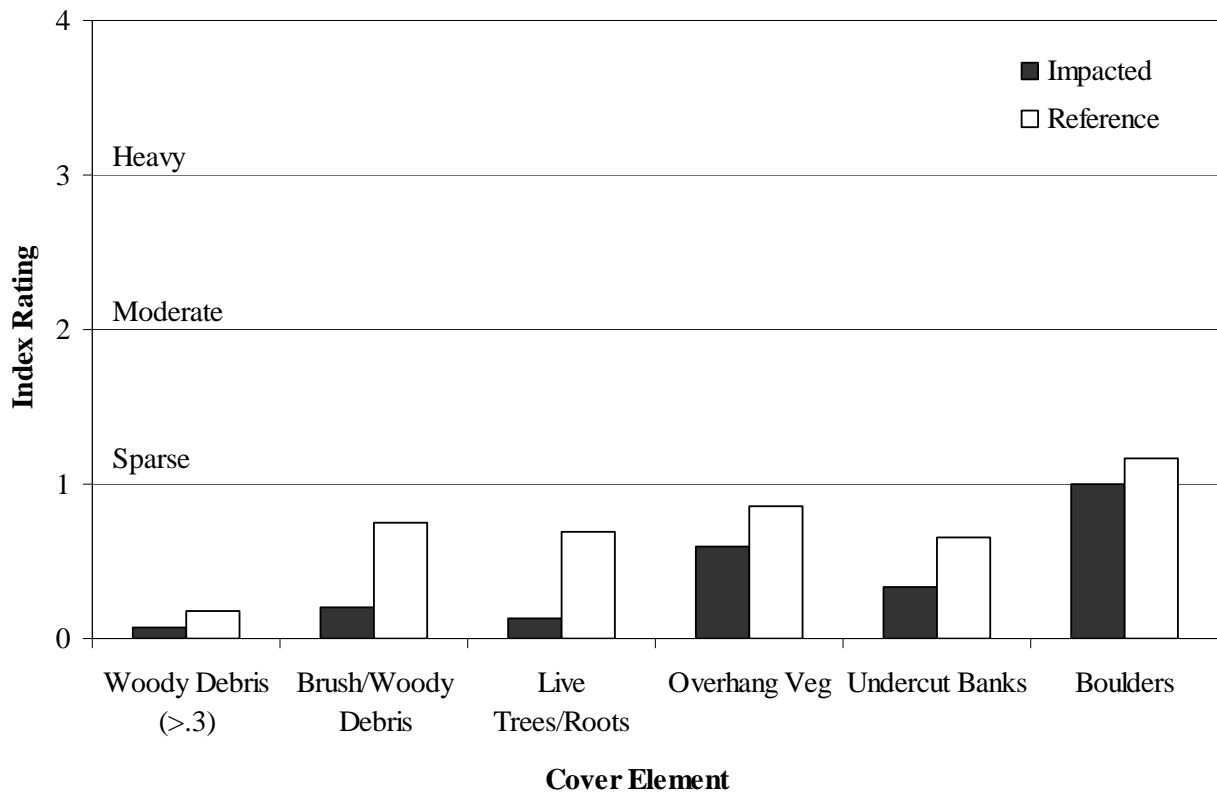
Figure 4. Fish cover index ratings for six cover elements assessed during physical habitat assessments of the South River in August 2012.

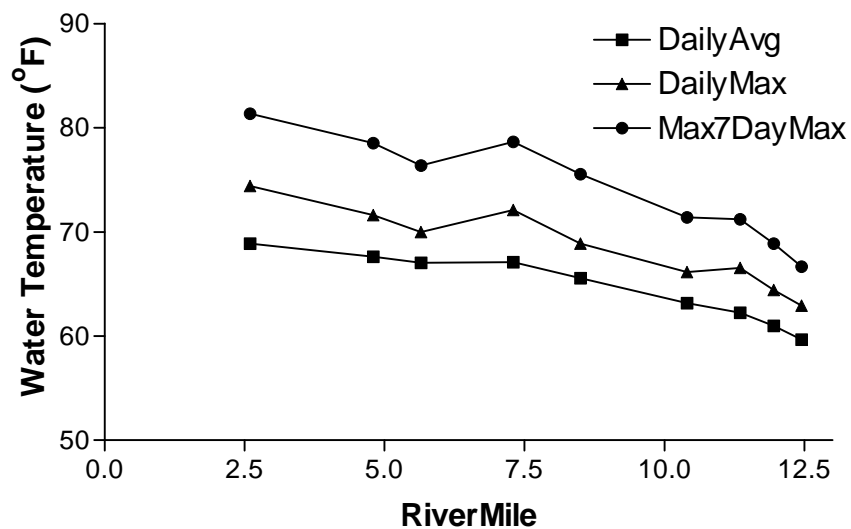
Figure 5. Water temperature metrics by river mile along the South River, summer 2012.

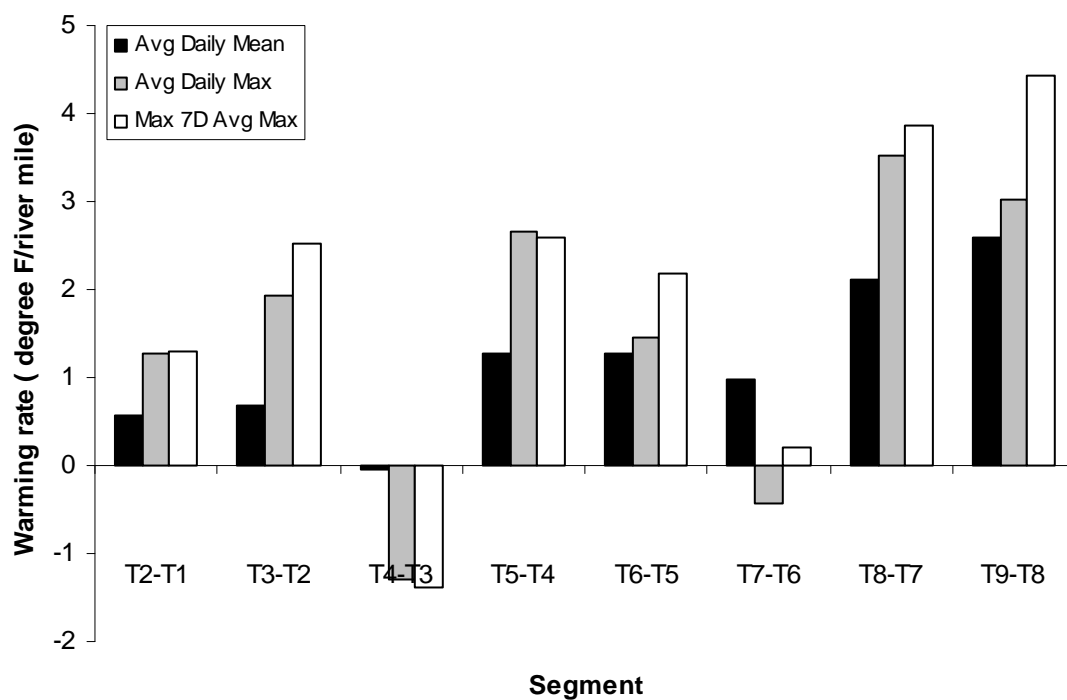
Figure 6. Summer 2012 water temperature warming rates calculated between temperature monitoring stations on the South River.

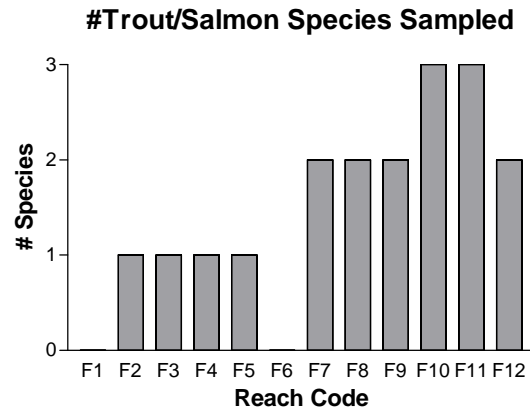
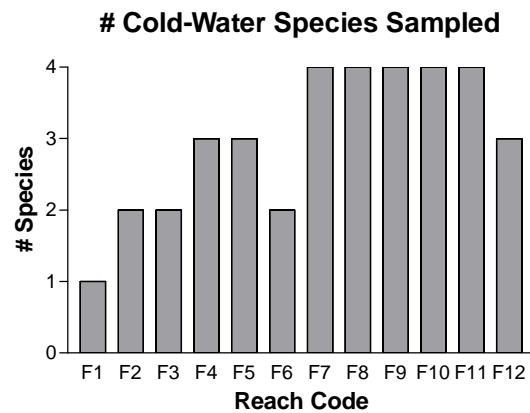
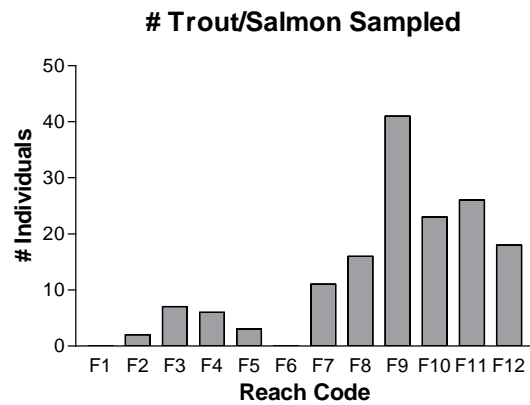
Figure 7. Fish metrics calculated from fish surveys performed in 11 reaches in the South River and 1 reach in Creamery Brook in August 2012.

As observed with a number of physical habitat variables and water temperature metrics, metrics used to describe fish community condition exhibited longitudinal trends (upstream

versus downstream; Figure 7). The number of salmonid species (brook trout, brown trout, and Atlantic salmon) ranged from 0 to 3. Atlantic salmon, captured from reaches F2, F3, and F4, were the only salmonid captured below river mile 10, although a brook trout was observed evading capture immediately below the confluence with Pumpkin Hollow Brook.. Brook trout were sampled only above river mile 10 and brown trout were sampled only above river mile 11.3.

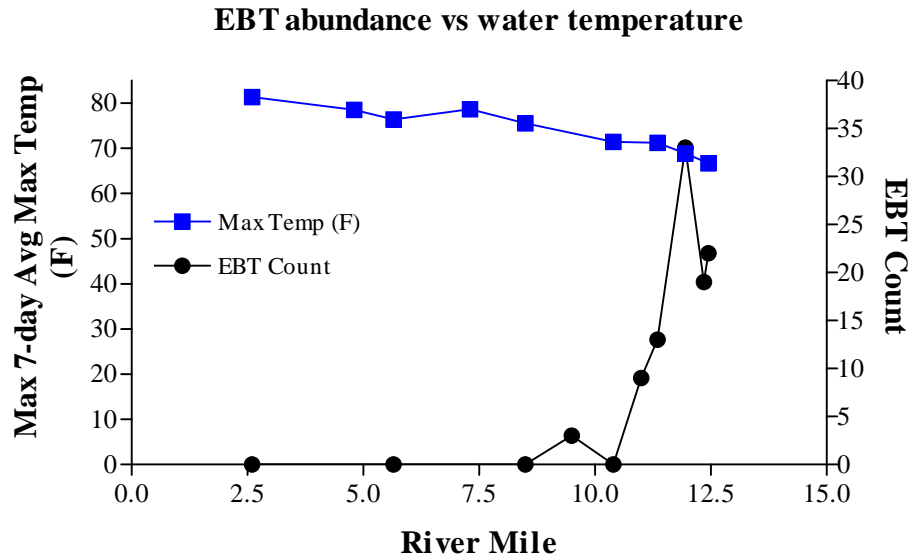
Figure 8. Number of brook trout captured plotted against maximum 7-day average maximum water temperatures in the South River, August 2012.

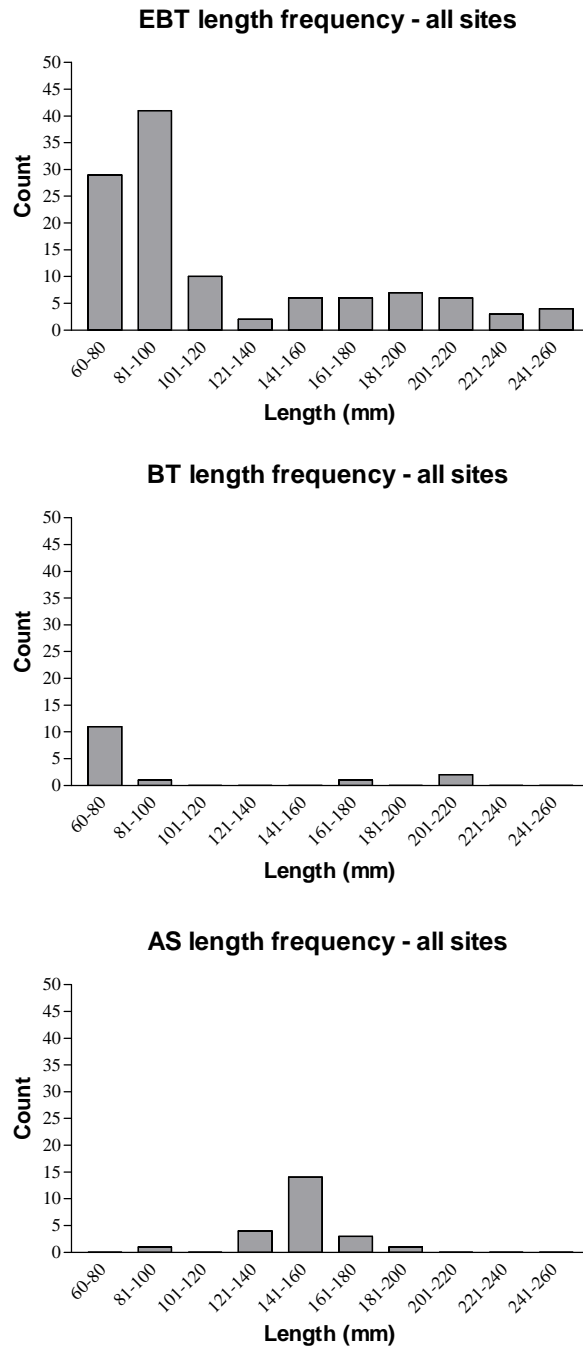
Figure 9. Length frequencies of trout and salmon sampled from the South River in August 2012. EBT = eastern brook trout, BT = brown trout, and AS = Atlantic salmon.

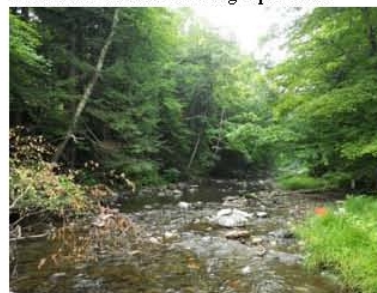
Downstream End - Facing Upstream

% Fines (FN)	4.8
% Sand (SA)	10.5
% Gravel, Fine (GF)	18.1
% Gravel, Coarse (GC)	14.3
% Cobble (CB)	29.5
% Boulder (BL)	22.9
% Bedrock (BR)	0.0
% Wood (WD)	0.0
% Hardpan (HP)	0.0
% Embeddedness	48.1
Mean Particle Size (mm)	319.0
Large Wood Tally (pieces/100 m)	0.00

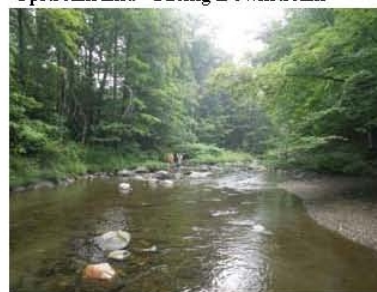
Upstream End - Facing Downstream

Bank Stability Rating (1-20)	10
Bank Protective Veg Rating (1-20)	0
Incised Bank Height (m)	0

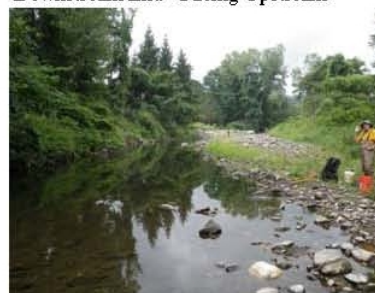
Downstream End - Facing Upstream

% Fines (FN)	9.5
% Sand (SA)	19.0
% Gravel, Fine (GF)	20.0
% Gravel, Coarse (GC)	17.1
% Cobble (CB)	28.6
% Boulder (BL)	5.7
% Bedrock (BR)	0.0
% Wood (WD)	0.0
% Hardpan (HP)	0.0
% Embeddedness	70.2
Mean Particle Size (mm)	98.9
Large Wood Tally (pieces/100 m)	0.00

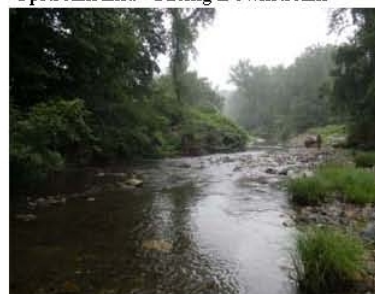
Upstream End - Facing Downstream

Bank Stability Rating (1-20)	12
Bank Protective Veg Rating (1-20)	0
Incised Bank Height (m)	0

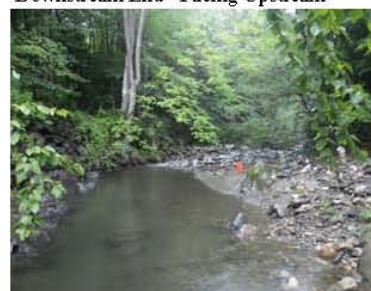
Downstream End - Facing Upstream

% Fines (FN)	0.0
% Sand (SA)	3.8
% Gravel, Fine (GF)	3.8
% Gravel, Coarse (GC)	11.4
% Cobble (CB)	28.6
% Boulder (BL)	48.6
% Bedrock (BR)	3.8
% Wood (WD)	0.0
% Hardpan (HP)	0.0
% Embeddedness	27.3
Mean Particle Size (mm)	994.9
Large Wood Tally (pieces/100 m)	0.00

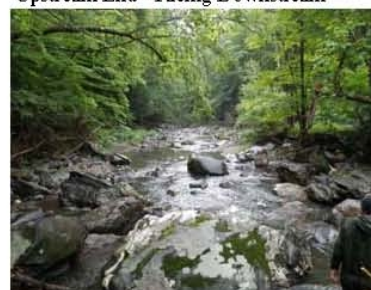
Upstream End - Facing Downstream

Bank Stability Rating (1-20)	12
Bank Protective Veg Rating (1-20)	0
Incised Bank Height (m)	0

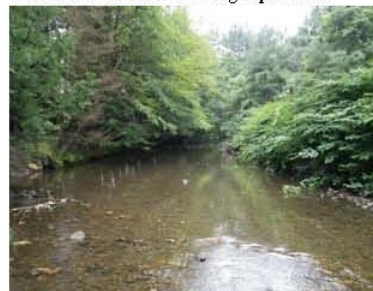
Downstream End - Facing Upstream

% Fines (FN)	10.8
% Sand (SA)	12.3
% Gravel, Fine (GF)	15.4
% Gravel, Coarse (GC)	23.1
% Cobble (CB)	32.3
% Boulder (BL)	6.2
% Bedrock (BR)	0.0
% Wood (WD)	0.0
% Hardpan (HP)	0.0
% Embeddedness	60.6
Mean Particle Size (mm)	112.0
Large Wood Tally (pieces/100 m)	0.00

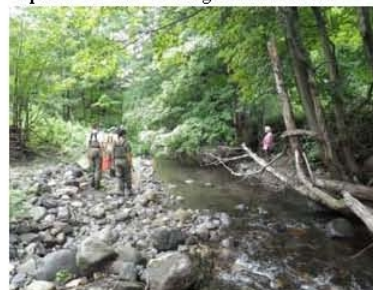
Upstream End - Facing Downstream

Bank Stability Rating (1-20)	12
Bank Protective Veg Rating (1-20)	0
Incised Bank Height (m)	0

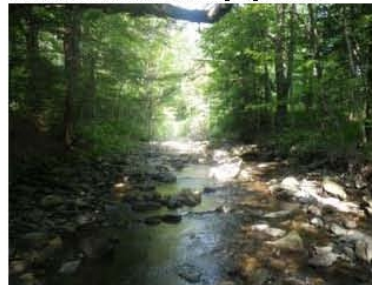
Downstream End - Facing Upstream

% Fines (FN) 0.0  
 % Sand (SA) 2.0  
 % Gravel, Fine (GF) 7.9  
 % Gravel, Coarse (GC) 20.8  
 % Cobble (CB) 38.6  
 % Boulder (BL) 28.7  
 % Bedrock (BR) 0.0  
 % Wood (WD) 0.0  
 % Hardpan (HP) 2.0  
 % Embeddedness 28.0  
 Mean Particle Size (mm) 329.9  
 Large Wood Tally (pieces/100 m) 0.00

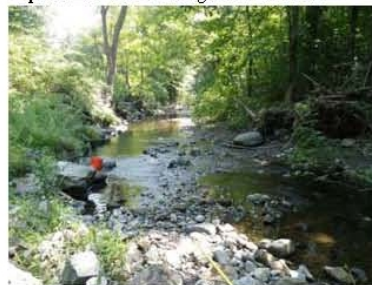
Upstream End - Facing Downstream

Bank Stability Rating (1-20) 13  
 Bank Protective Veg Rating (1-20) 0  
 Incised Bank Height (m) 0

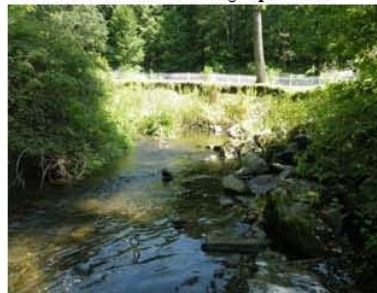
Downstream End - Facing Upstream

% Fines (FN)	3.8
% Sand (SA)	19.0
% Gravel, Fine (GF)	16.2
% Gravel, Coarse (GC)	36.2
% Cobble (CB)	17.1
% Boulder (BL)	7.6
% Bedrock (BR)	0.0
% Wood (WD)	0.0
% Hardpan (HP)	0.0
% Embeddedness	45.2
Mean Particle Size (mm)	94.3
Large Wood Tally (pieces/100 m)	5.33

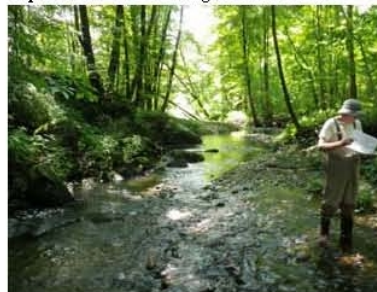
Upstream End - Facing Downstream

Bank Stability Rating (1-20)	0
Bank Protective Veg Rating (1-20)	0
Incised Bank Height (m)	1

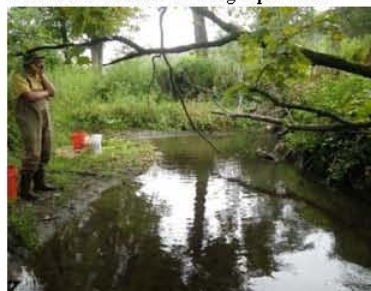
Downstream End - Facing Upstream

% Fines (FN)	7.6
% Sand (SA)	21.9
% Gravel, Fine (GF)	18.1
% Gravel, Coarse (GC)	36.2
% Cobble (CB)	16.2
% Boulder (BL)	0.0
% Bedrock (BR)	0.0
% Wood (WD)	0.0
% Hardpan (HP)	0.0
% Embeddedness	48.9
Mean Particle Size (mm)	45.3
Large Wood Tally (pieces/100 m)	2.67

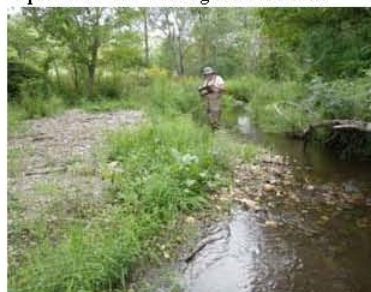
Upstream End - Facing Downstream

Bank Stability Rating (1-20)	14
Bank Protective Veg Rating (1-20)	0
Incised Bank Height (m)	0

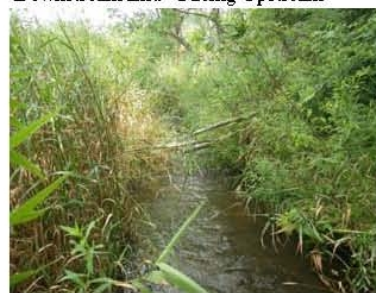
Downstream End - Facing Upstream

% Fines (FN)	8.1
% Sand (SA)	11.1
% Gravel, Fine (GF)	15.2
% Gravel, Coarse (GC)	29.3
% Cobble (CB)	33.3
% Boulder (BL)	3.0
% Bedrock (BR)	0.0
% Wood (WD)	0.0
% Hardpan (HP)	0.0
% Embeddedness	43.3
Mean Particle Size (mm)	91.9
Large Wood Tally (pieces/100 m)	2.00

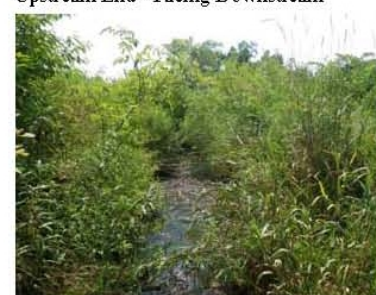
Upstream End - Facing Downstream

Bank Stability Rating (1-20)	16
Bank Protective Veg Rating (1-20)	0
Incised Bank Height (m)	0

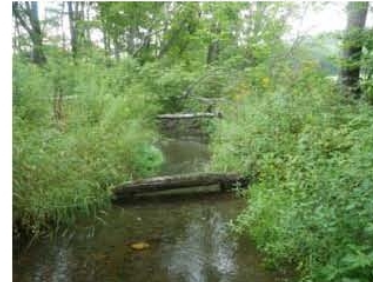
Downstream End - Facing Upstream

% Fines (FN)	9.6
% Sand (SA)	11.5
% Gravel, Fine (GF)	12.5
% Gravel, Coarse (GC)	39.4
% Cobble (CB)	26.0
% Boulder (BL)	1.0
% Bedrock (BR)	0.0
% Wood (WD)	0.0
% Hardpan (HP)	0.0
% Embeddedness	43.0
Mean Particle Size (mm)	70.6
Large Wood Tally (pieces/100 m)	17.33

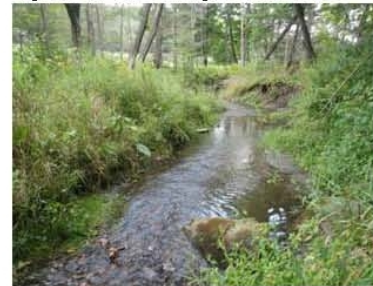
Upstream End - Facing Downstream

Bank Stability Rating (1-20)	16
Bank Protective Veg Rating (1-20)	0
Incised Bank Height (m)	0
